FINAL REPORT

HYDRAZINE BLENDING AND STORAGE FACILITY WASTEWATER TREATMENT AND DECOMMISSIONING ASSESSMENT

VERSION 3.1

June 1988

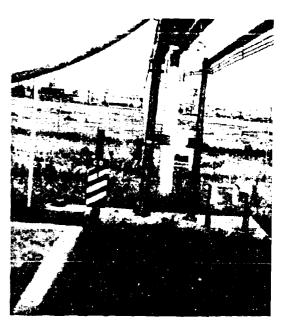
Plate No. 20
West elevation of steel structure over pump pit

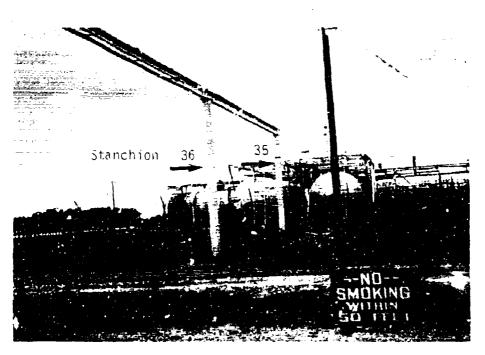
Plate No. 24 Stanchions 35-40 viewed from US-3 looking west

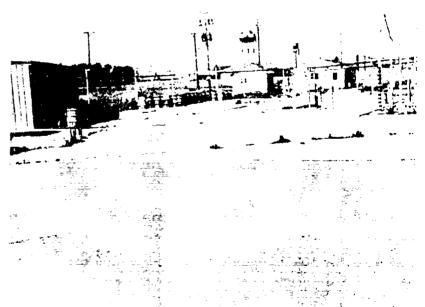
Plate No. 29 25-kV4 transformer near tank US-4

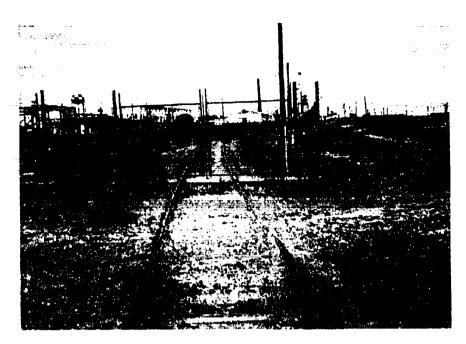
Plate No. 30 Truck turnaround area
